Refurbishment of the KCP&L La Cygne Hydrogen Cooled Brushless Exciter

By

**George Yeboah
KCP&L**

**Bill Moore & Tony McConnon
NEC**

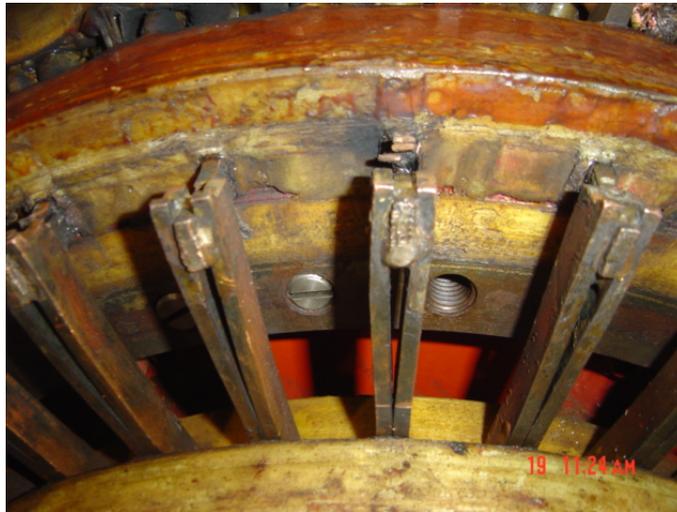
The unit was received February 18, 2005 to inspect and provide a report on the potential repair options. Numerous phase leads were either cracked or partially cracked at the electrical connection to the vertical phase lead riser. The phase lead riser retention band which had also failed, had been previously located by the Customer during generator disassembly.

Figure 2. - Damaged Phase Leads

The most likely failure scenario involved crack initiation by failure of the phase lead riser band. This band covers the phase lead risers, and also the phase lead coil extensions as they come out to the risers. Loss of support in this area, quickly led to a failure in shear of the coil extensions. Arcing damage was also noted in this area.

Based upon the extent of the damage found, NEC's recommendation to KCP&L was to rewind the AC exciter armature. KCP&L accepted this recommendation and NEC initiated an armature rewind on February 21, 2005.

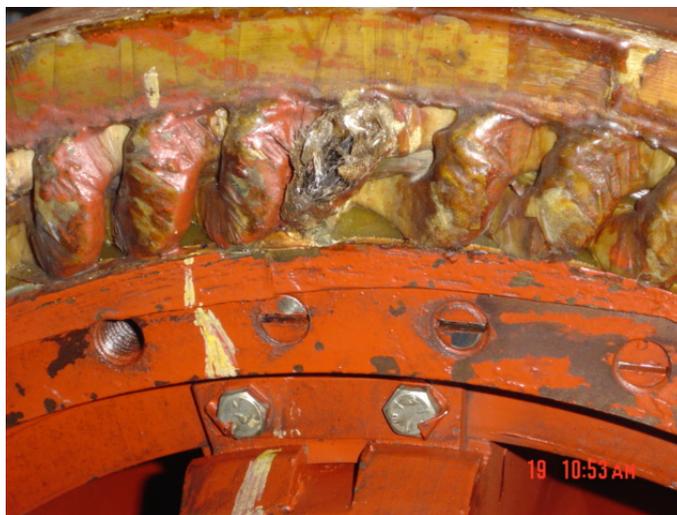
During the initial visual inspection at NEC, the damage to the phase lead connections was confirmed. Visual inspection, likewise, discovered armature coil damage at both the inboard and outboard coil connections.

Figure 3 – Damaged Outboard Coil Connection

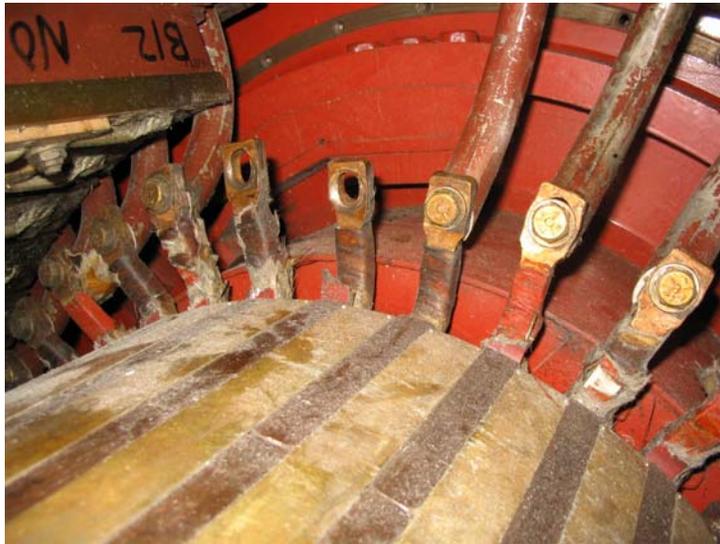
During disassembly of the diode wheel components, it was discovered that 34 of the 36 phase lead connectors had "deformed." These connectors are aluminum and provide the electrical connection between the phase leads and the diode wheel modules (see figure below).

Figure 4 – Normal Connector Depicted in Center; Two Deformed Connectors Shown to the Right

These connectors were replaced with a modified design that provided a stiffer connector consisting of a cross section 1" by 1" instead of the original 7/8" diameter (see picture below).

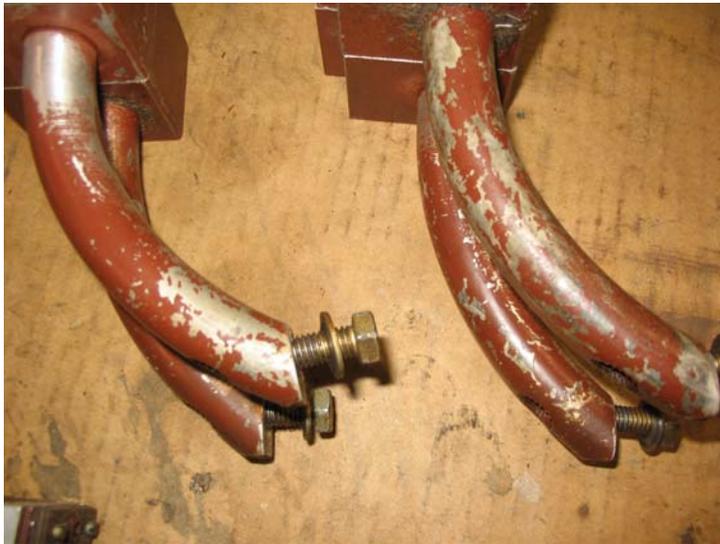
Figure 5 – Deformed Connectors Depicted on Top

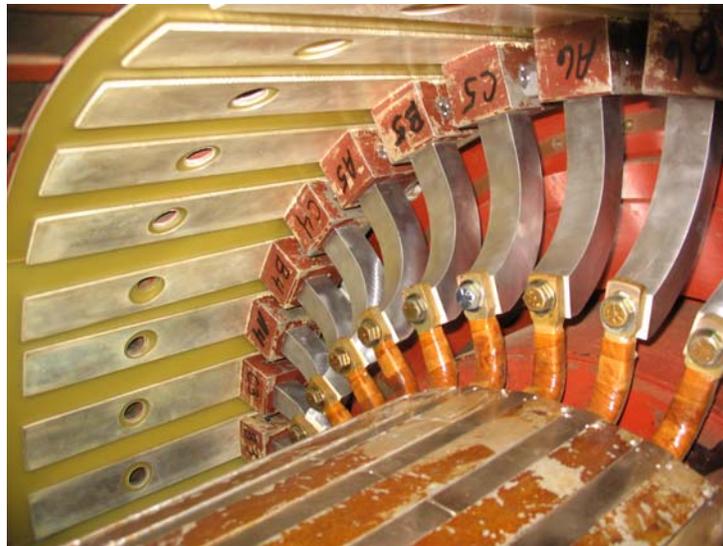
Figure 6 – New Phase Lead Connectors

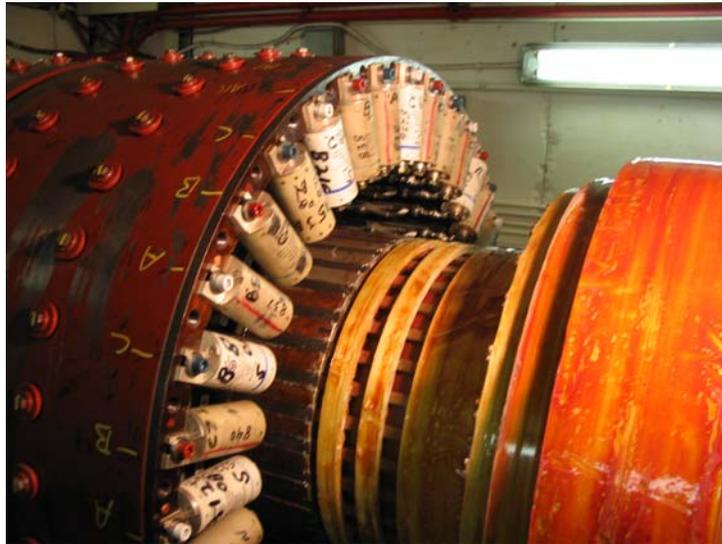
Kansas City Power & Light supplied NEC with twenty-four new 'folded' element fuses. This left a balance of 27 original fuses that exhibited fuse resistances higher than recommended maximum fuse resistance. KCP&L stated that it had ordered replacement new fuses and would install them during a future mini-outage.

Figure 10 – High Resistance Fuses Identified with Red Stripe

To minimize the effect of the higher resistance fuses, NEC installed the 27 'best' of the original 51 high-resistance fuses and distributed them equally around the six phase groups. To aid in identifying the high-resistance fuses, a red stripe was applied on the side of the fuses.

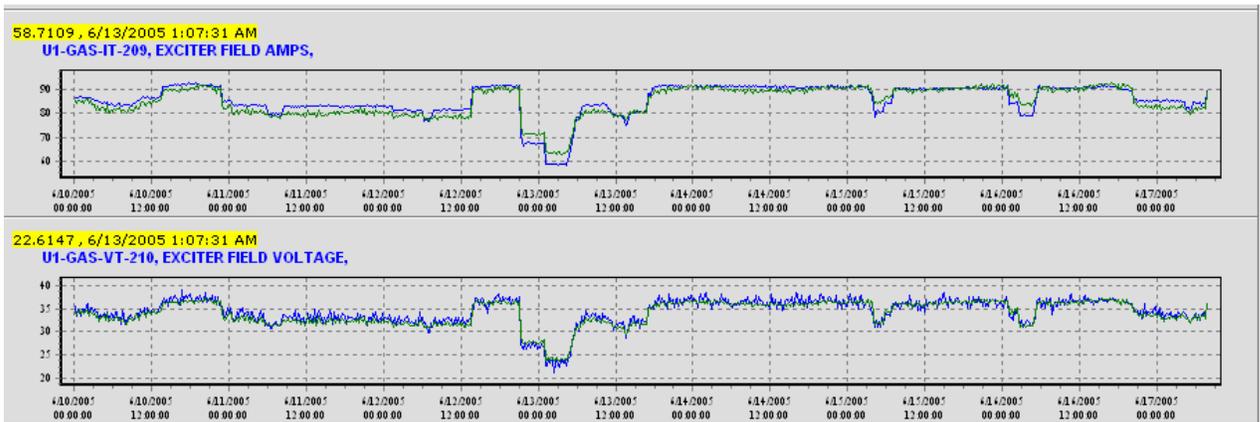
After the start-up was completed and the unit running at full load, the exciter DC currents was measured and the level was lower than the pre-outage level. As shown in the graph below, the exciter field current is approximately 90 amps. Prior to the outage, levels exceeded 100 amps.
