# **Condition Assessment Evaluation & Planned Design Improvements for the Cowes Generator William G. Moore, P.E. National Electric Coil U.S.A.**

## **ABSTRACT**

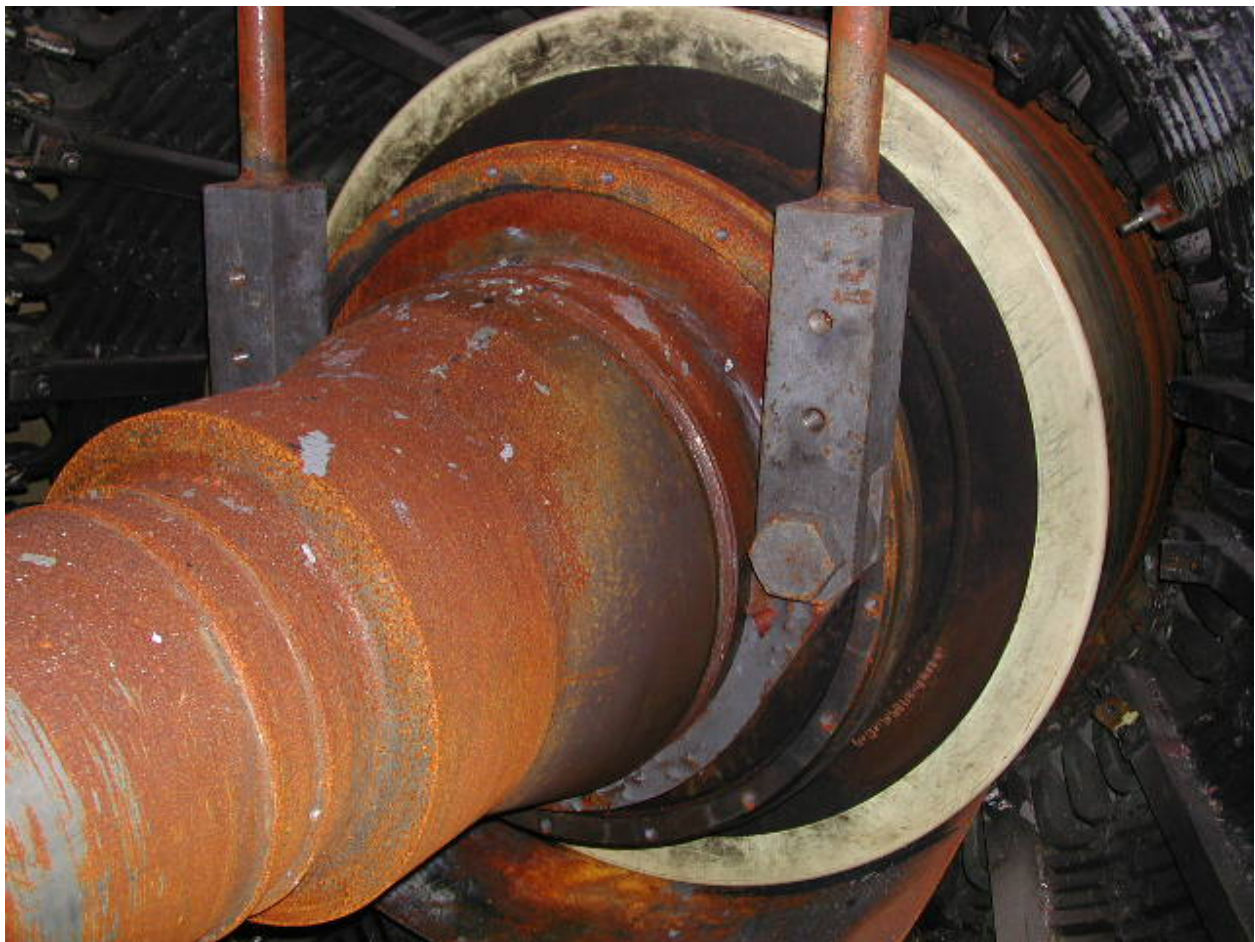
An initial inspection was done of the rotor as it sat at the owner's site. Based on visual inspection alone, it wasn't clear if the rotor forging could be reused or not. It was recommended that a re-qualification program be developed to determine the suitability of repairing the rotor and returning it back to service. Tests and evaluations, such as TIR (Total Indicator Runouts) and concentricity checks, hardness mapping, metallurgical replicas, and material sampling with Charpy and elongation checks, would be done. Gages would be made to check all the slots. The highest degree of concern would be the material properties and integrity of the generator rotor forging. The exciter end of the rotor forging was in close proximity, if not at the center of the fire. Figure 1 shows the exciter end of the generator rotor and is shown below.

**Figure 1: Exciter end of the generator rotor.**

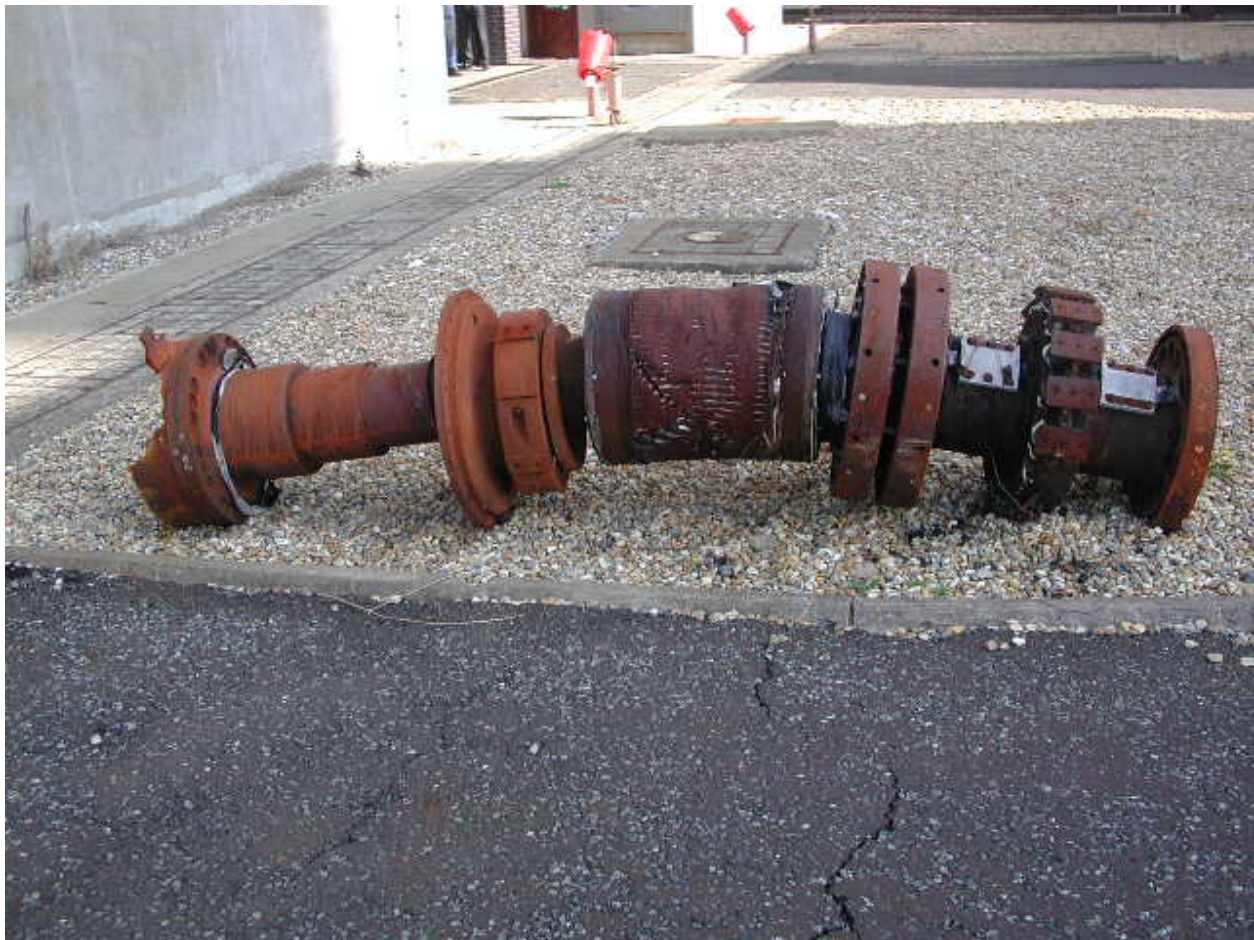
The exciter had a severely bent shaft, measurable in inches. Several of the coupling bolts in the generator's exciter end coupling were severely bent from the heating and impossible to remove from the generator rotor coupling.

New seals and bearings would be necessary. It was felt that it might be possible to re-use the bearing casing and pedestals. There was no obvious distortion of the rotor shaft or couplings. The connection coupling was damaged and would need to be replaced. A photo of the bent exciter shaft is shown below.

**Figure 2: Damage to the exciter from the fire was extensive..**

Since the exciter was a total loss, two options were considered to completely replace the exciter. The first was a direct replacement of the existing exciter, with the same configuration and function as the original one. The second option was replacement with a static excitation system that would provide the same function as the original excitation equipment. A replacement exciter shaft, identical to the original would be utilized. The shaft would incorporate slip rings that will feed the current through brushes to the generator rotor. Both options are more fully described below.

The static excitation option offered a significantly lower price, as well as the promise of less maintenance. It was chosen as the best alternative for the replacement of the exciter.

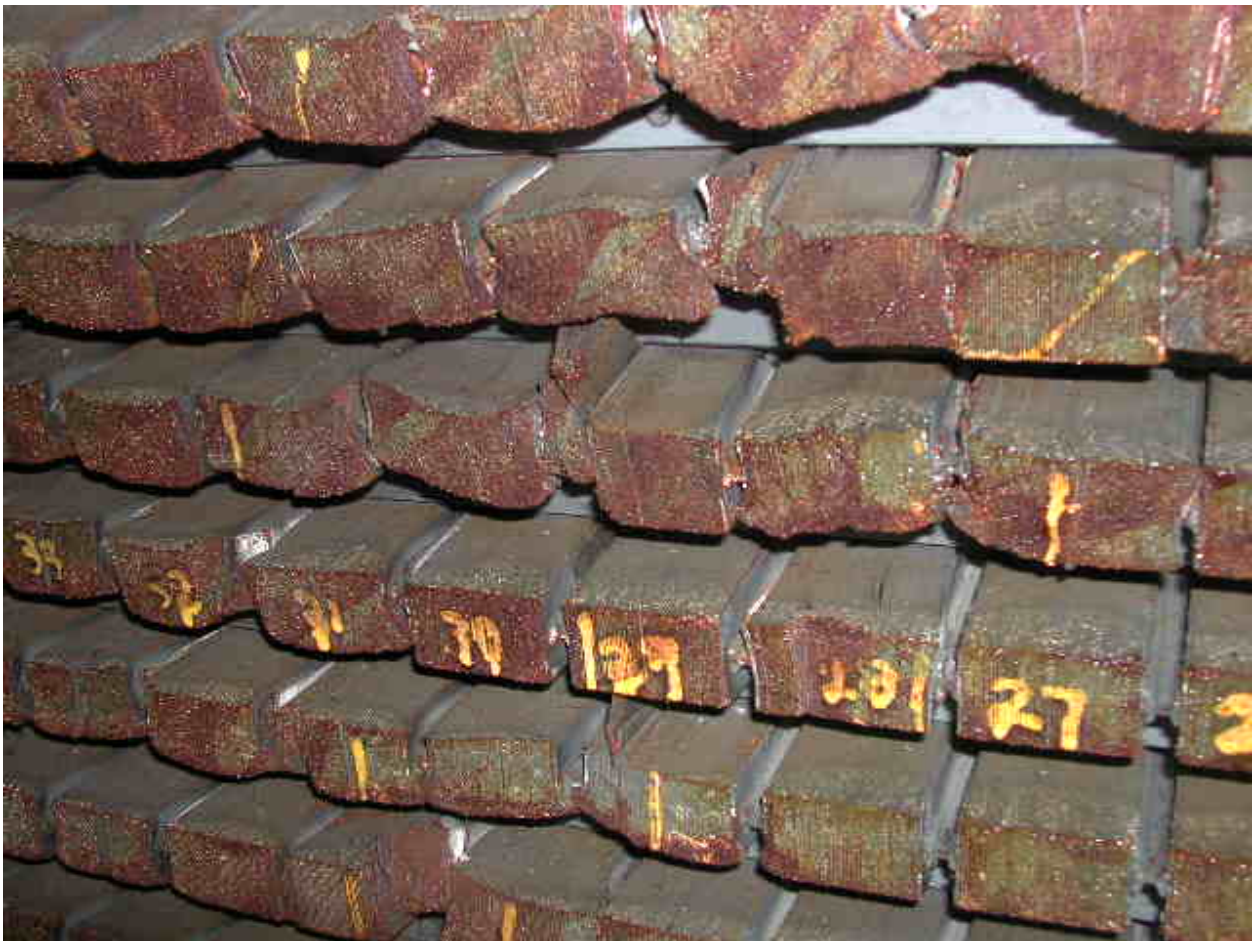
Due to the damage from the expelled rotor slot wedge and rotor copper, as well as the heat from the fire, it was readily apparent that the stator winding and core had to be replaced. The damage to the stator core, as shown in Figure 3, was not limited to just one end of the stator. Therefore, a partial restack was not possible. The damage was found throughout the entire core. There were no obvious signs of melting of the core pressing plate, key bars, or other components. There were no obvious signs of paint blistering on these parts, but the winding had areas of heavy accumulations of soot, and the insulating clip caps at the ends of the bars had obviously melted, as shown in Figure 4.

**Figure 3: Stator core laminations were displaced due to heat and mechanical pressure over the length of the slot.**

New stator core laminations were manufactured using low loss silicon steel. The generator was transported across the channel to another power plant site, where crane and other service accessibility was much better. The generator was stripped, restacked and rewound at this new location, and then transported by transport back to the Isle of Wight.

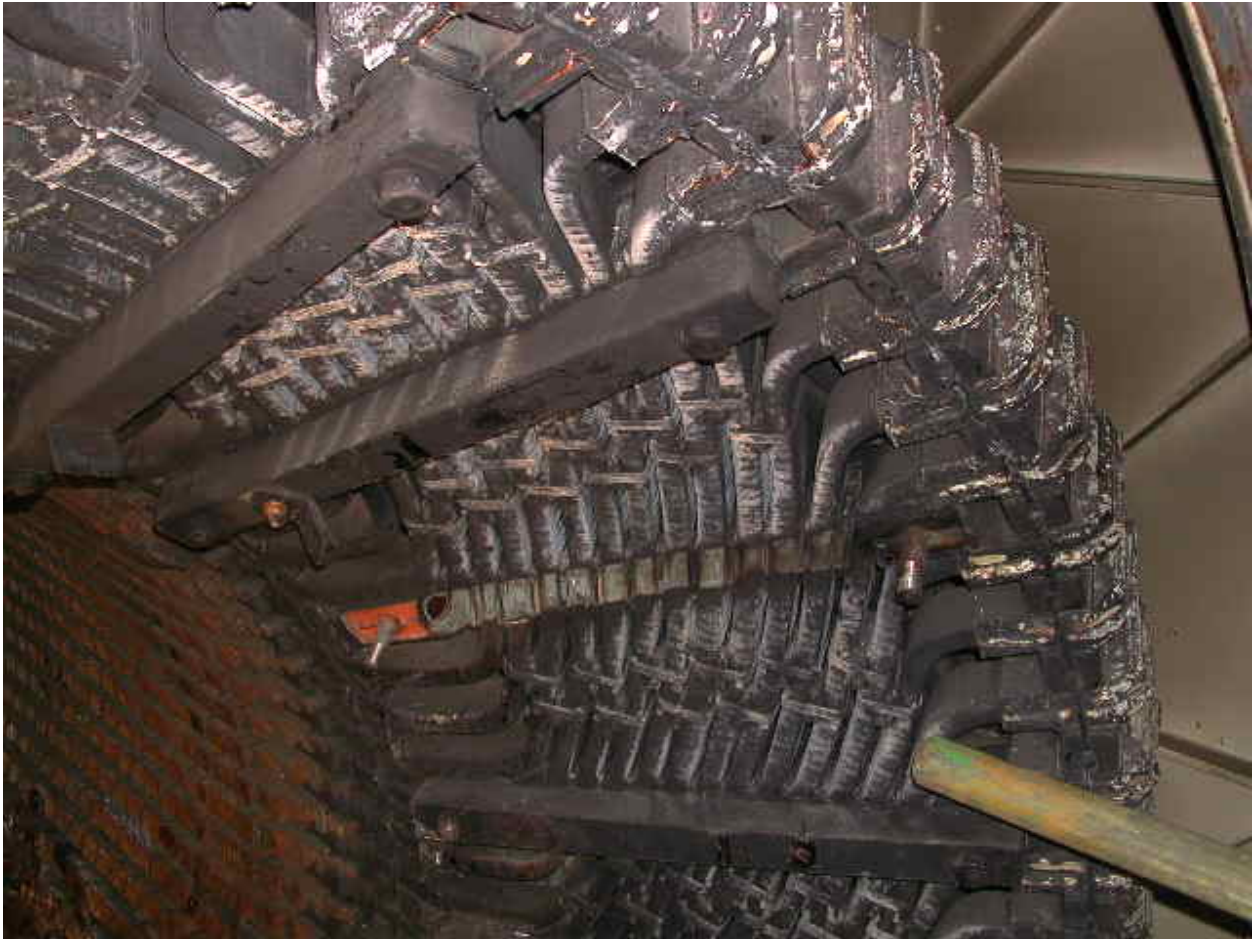
**Figure 4: Soot covered exciter end of the generator stator winding is shown above. Notice the heat damage to the insulating clip caps at the ends of the bars.**

The new stator winding incorporated a 540 degree Roebel transposition in the slot portion, but otherwise essentially duplicated the original design configuration, since no uprate was required. Ripple springs were incorporated to improve long lasting wedge tightness and to maintain the coil tight and resist steady state slot pounding forces over time. Bar manufacturing processes, and all electrical testing was performed based on strict quality control standards and according to customer requirements.

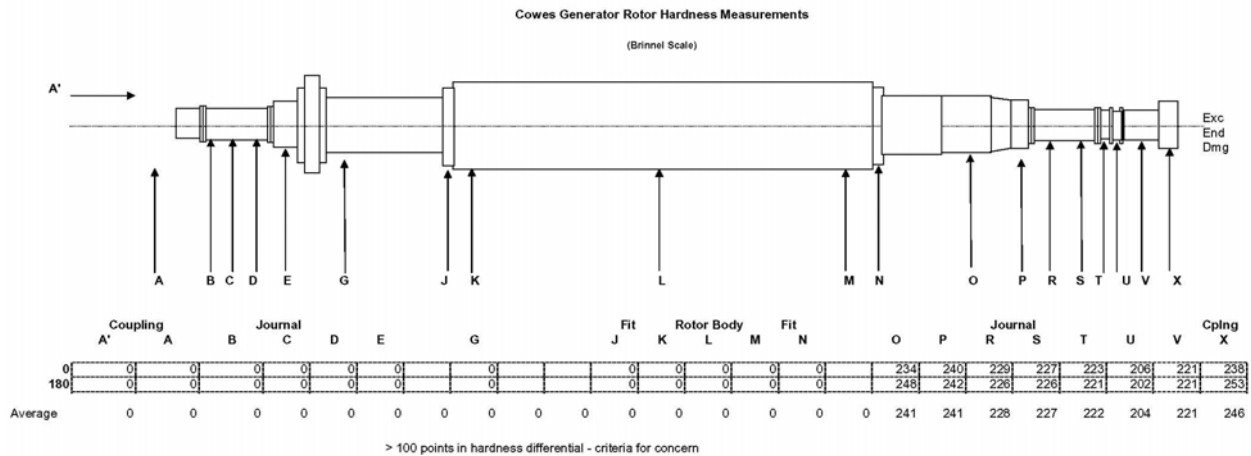
Rotor hardness tests were conducted over the entire length of the rotor shaft forging, particularly at the heat damaged exciter end. Two locations were chosen, 180 degrees apart, at each major diameter of the rotor. Figure 5 shows the overall geometry of the rotor, and the hardness reading results in Brinell. Surprisingly, no hardness locations were observed, and, even at the heat-damaged end, the overall criteria of a 100 point hardness differential was not violated. Hardness readings ranged from about 250 BHN to about 200 BHN, which is well in the expected range for this material. As a result of these tests, no etching was done on any specific area.

**Figure 5: Hardness results in Brinell.**

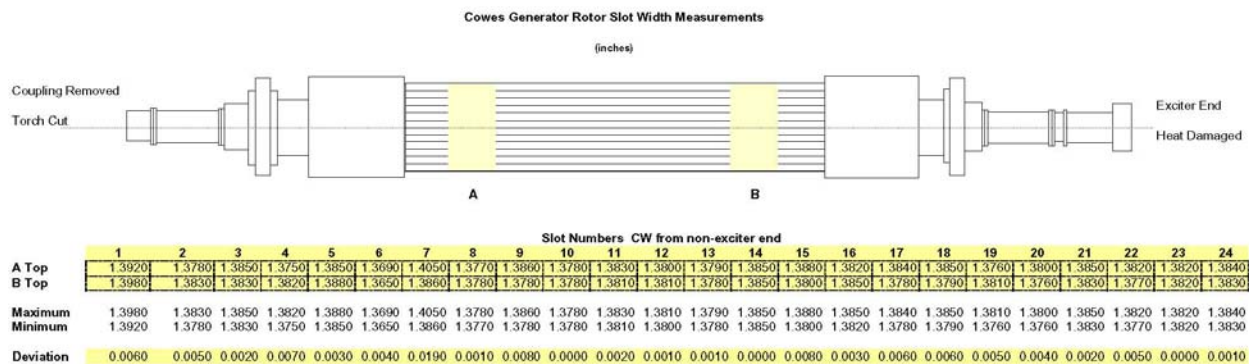
Slot width measurements were taken at two axial locations, in each and every slot, because even small variations in slot width can necessitate extensive repair or even replacement of the forging. It was suspected that substantial warping of the slot width had occurred at the exciter end, due to displacement of the rotor teeth from the excessive heat. Surprisingly, once again, significant variation in slot width was not observed in any of the slots. A detailed summary of the measurements is shown in Figure 6.

**Figure 6: Slot width measurements.**

One slot, number 7, did showed a difference of 0.019 inches between the turbine and exciter ends. This was rechecked and reconfirmed. It was seen as possible that this difference could have been a machining deviation from the original manufacture of the rotor, since any dimensional changes due to overheating would have been more widely evident in the other slots.

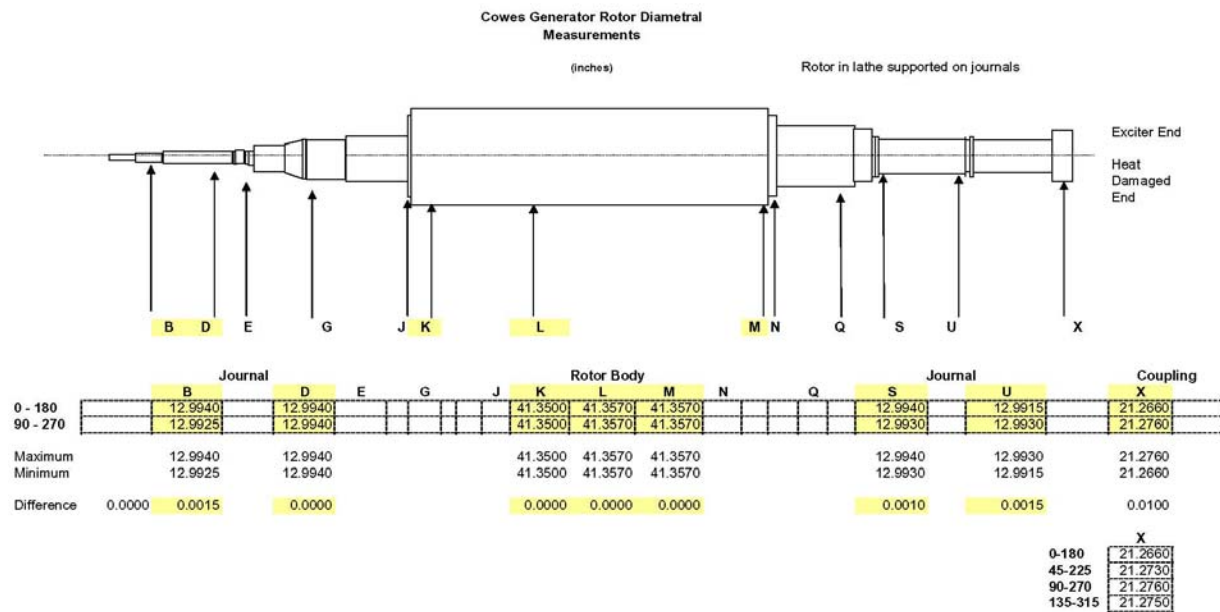
Diameter measurements were taken at various axial lengths of the rotor. Two measurements were taken at each location. Any significant lump or protrusion due to heat distortion would be picked up. Results of the measurements are shown in Figure 7.

**Figure 7: Results of diametral measurements.**

These diametral measurements did not show any significant distortion of the rotor. Even the generator coupling at the exciter end, which experienced the most heat, had only a 0.010 inch difference between the two measurements.

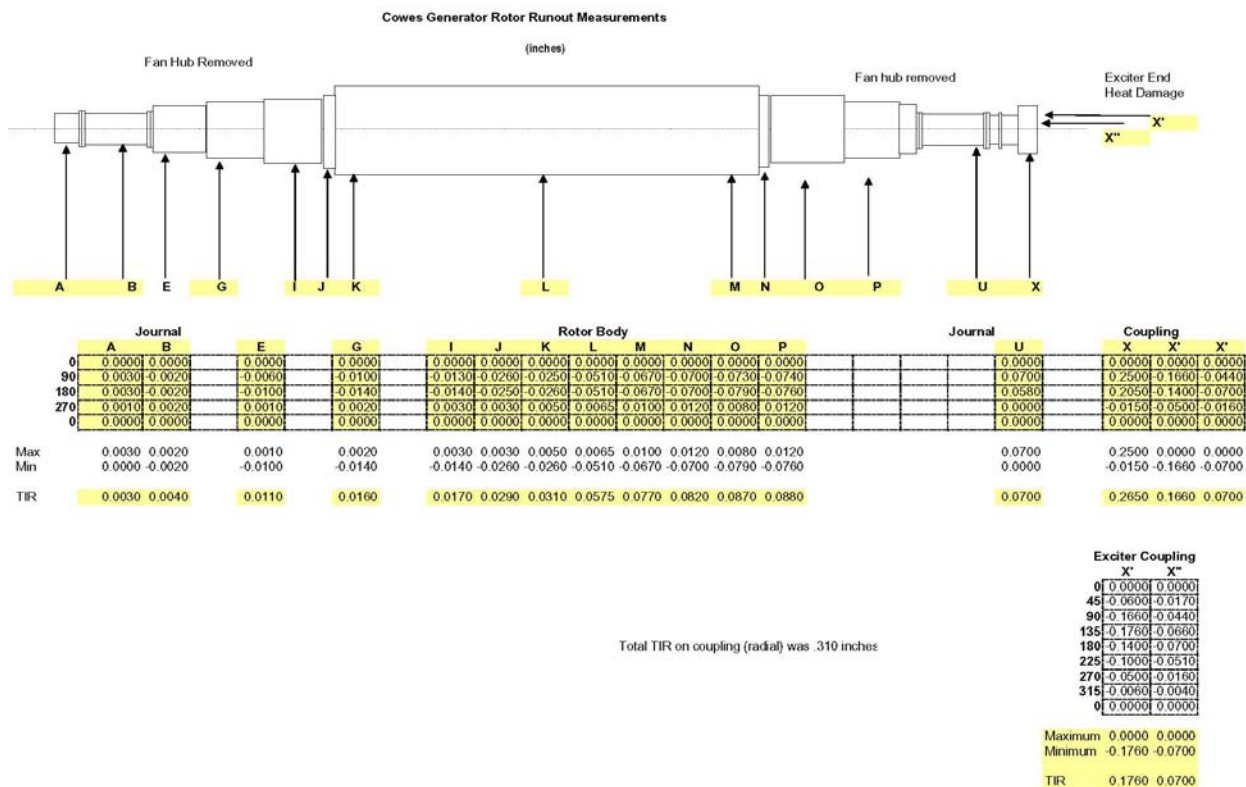
Figure 8: Results of TIR readings.

Runout readings were taken with the rotor in the lathe. This measurement would indicate if the rotor shaft is bent in any manner. Results are summarized in Figure 8. Total Indicator Runout (TIR) readings showed a sharp bend in the rotor shaft near the exciter end of the generator rotor. The coupling, for instance had a total TIR of 0.310 inches in the radial direction. Results of the axial runouts taken on the face of the coupling were excessive also, with readings of 0.176 inches near the outer diameter rim of the coupling. These measurements clearly indicated a significant bend in the rotor shaft. The repair method would require either the removal of the shaft end and re-welding or the complete replacement of the rotor shaft.

Due to the large amount of distortion to the end of the rotor, consideration of the overall price of a weld repair option, and taking into account the complex process control required to ensure

integrity of a weld repair option, NEC recommended a new rotor forging. The new forging would have improved material properties over the original forging, and would be re-engineered to match the dimensions of the original rotor.

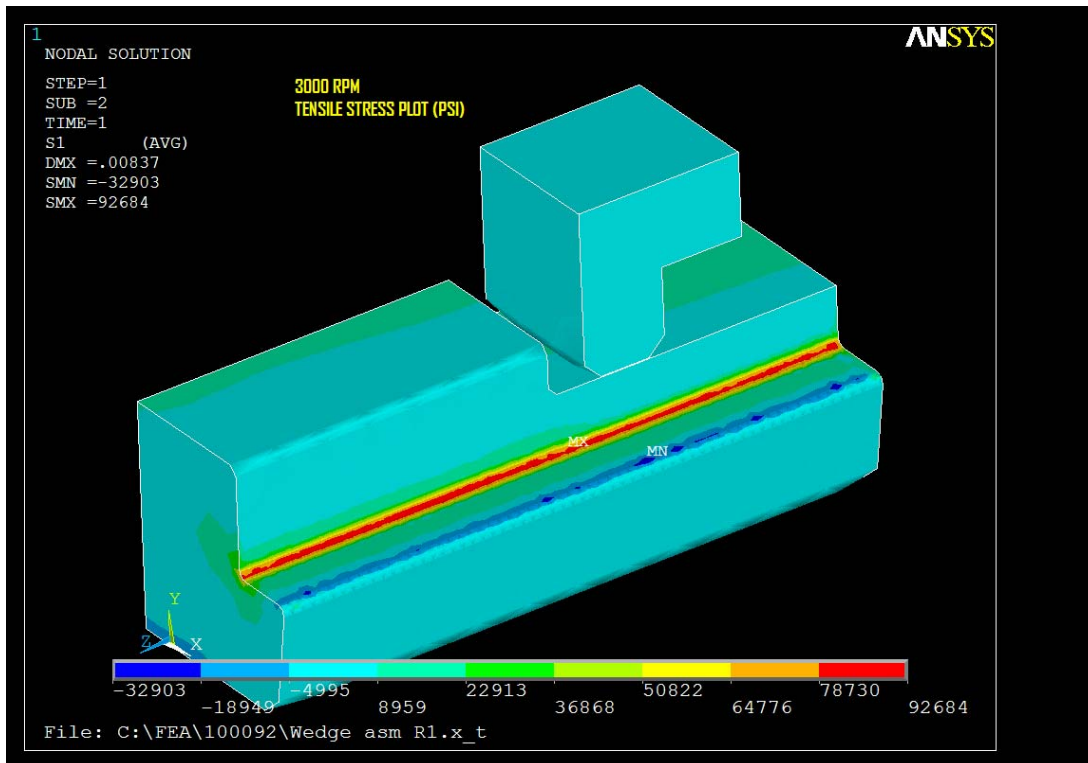
The existing rotor wedges were analyzed by classical and finite element methods. The analysis was performed at both operating speed (3000 rpm) and 20% over speed (3600 rpm). The maximum bending stress in the wedge was 356 MPa (51.6 ksi) and the shear stress was 73.7 MPa (10.7 ksi). Based on 7075-T6 Aluminum, with a tensile yield strength of 505 MPa, the factor of safety on yield was 1.4 (bending stress)

An ANSYS Finite Element Model was created to analyze the stresses in the old and new wedge designs. The model incorporated displacement of the rotor body at its end, as well as shrink fit from the retaining ring in the same area. An example of one of the stress plots of the wedges is shown below. The high stress concentration in the fillet radius of the wedge is clearly visible, as indicated by the bright red area.

Figure 9: Graphic representation of the results of the ANSYS Finite Model analysis.

In addition to other details, NEC proposed that the new rotor design include wedges with an increased radius of 3 mm at the shoulder. Incorporating this feature would increase the fatigue life of the wedges. Based on 7075-T6 Aluminum, the fatigue life would increase 60 times, to 32 million cycles, well beyond the low-cycle fatigue range.
