Refurbishment of the KCP&L La Cygne Hydrogen Cooled Brushless Exciter

By

**George Yeboah
KCP&L**

**Bill Moore & Tony McConnon
NEC**

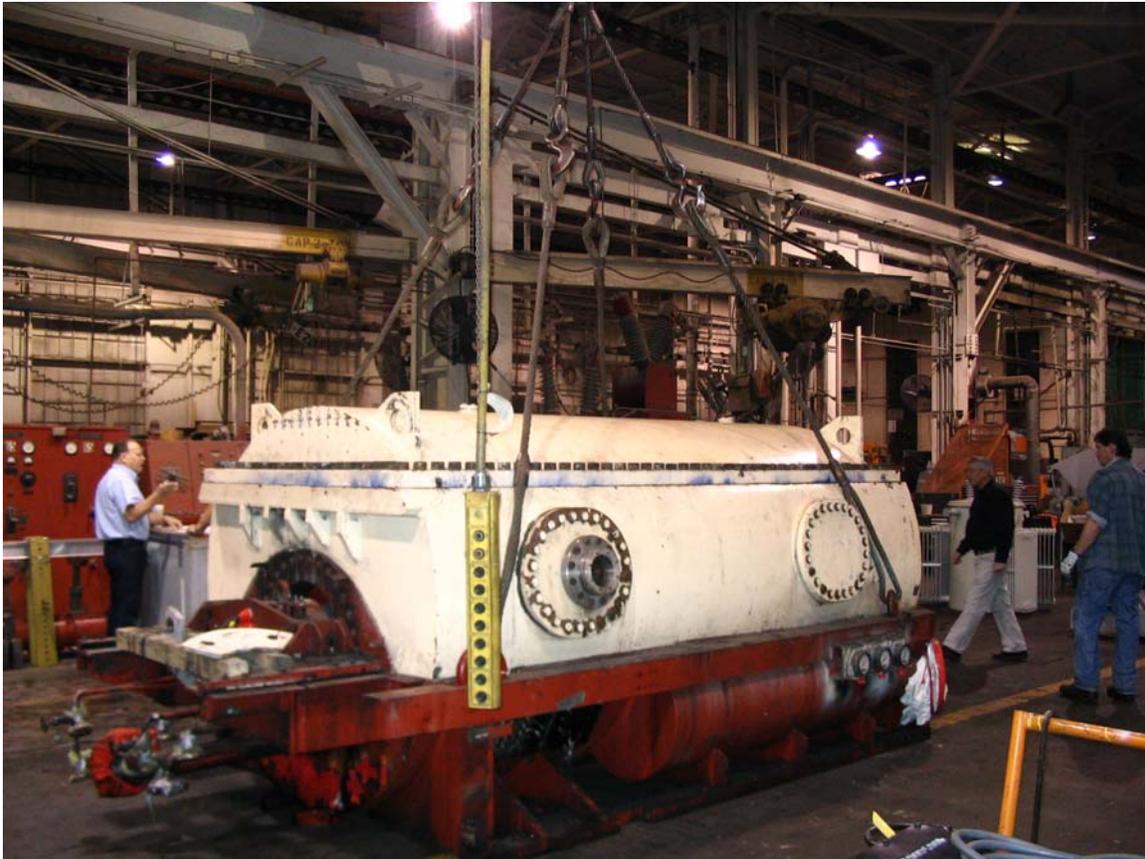
Fig. 1 Large 8000 amp hydrogen cooled brushless exciter upon first arrival at NEC for repair.

The unit was received February 18, 2005 to inspect and provide a report on the potential repair options. Numerous phase leads were either cracked or partially cracked at the electrical connection to the vertical phase lead riser. The phase lead riser retention band which had also failed, had been previously located by the Customer during generator disassembly.

During the initial visual inspection at NEC, the damage to the phase lead connections was confirmed. Visual inspection, likewise, discovered armature coil damage at both the inboard and outboard coil connections.

Based upon the extent of the damage found, NEC's recommendation to KCP&L was to rewind the AC exciter armature. KCP&L accepted this recommendation and NEC initiated an armature rewind on February 21, 2005.

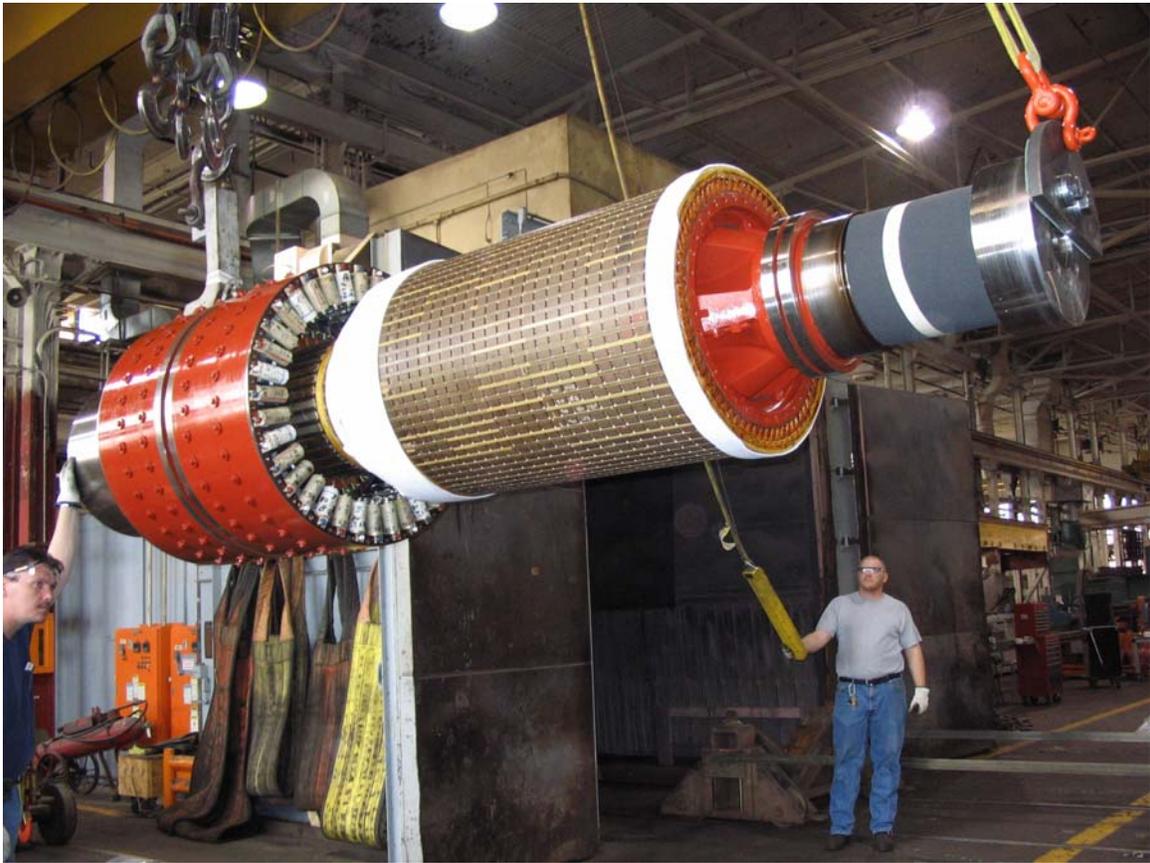
Fig. 7 Photo of rewound exciter coming out of balance pit.

After the fuses were installed, final resistance readings were taken on each fuse. The brushless exciter rotor assembly was high-speed balanced upon job completion. A ten percent over-speed test was performed to qualify the winding and band integrity.

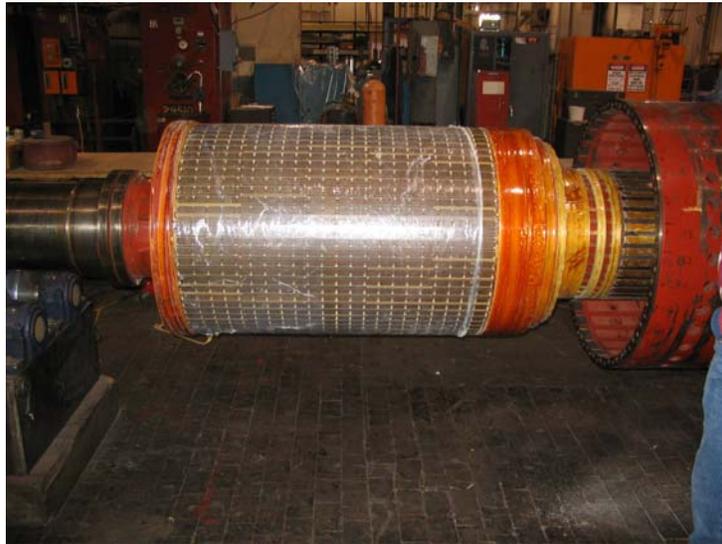
Figure 8– Completed AC Exciter Armature

The armature has seventy two slots and, thus, 72 coils. Each phase group consists of two coils; one end brazed to the neutral ring and the other to the phase lead riser. After the phase lead and neutral ring braze joints were completed, phase resistance measurements were taken to verify the integrity of the phase, neutral and series connections. Using a DLRO, resistance readings were measured between each phase lead riser to the neutral ring. Once all of final bands were applied and cured, the armature winding was subjected to final insulation resistance tests and hi-potential tests.

The AC armature winding process was completed March 30, 2005 and released for diode wheel re-assembly.

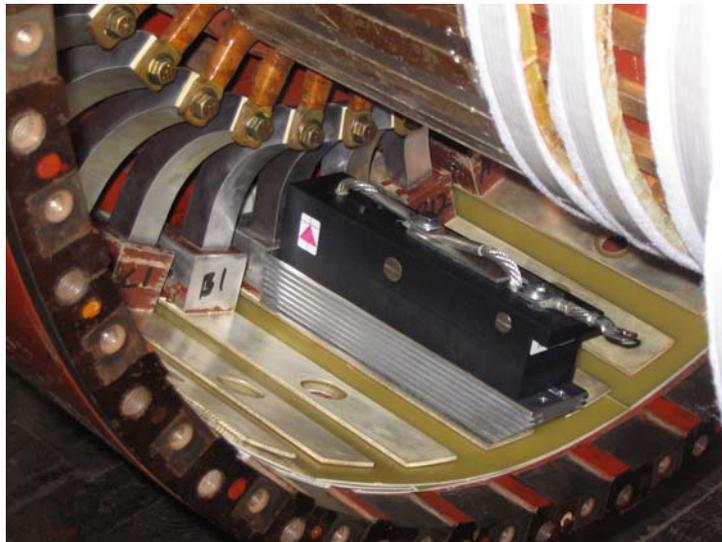
Each diode module consists of two diodes and a capacitor in parallel. There are 36 diode modules in each diode wheel. Each module was electrically tested to check the forward and reverse resistance of the diodes and the charging capacity of each capacitor. Three diodes were found to be either open circuit or low reverse resistance and 13 capacitors failed the electrical charge test.

Figure 9– New Diode Modules Supplied by Basler

Kansas City Power & Light elected to replace all the diode modules with new components. The diode modules were electrically tested at NEC prior to installation.

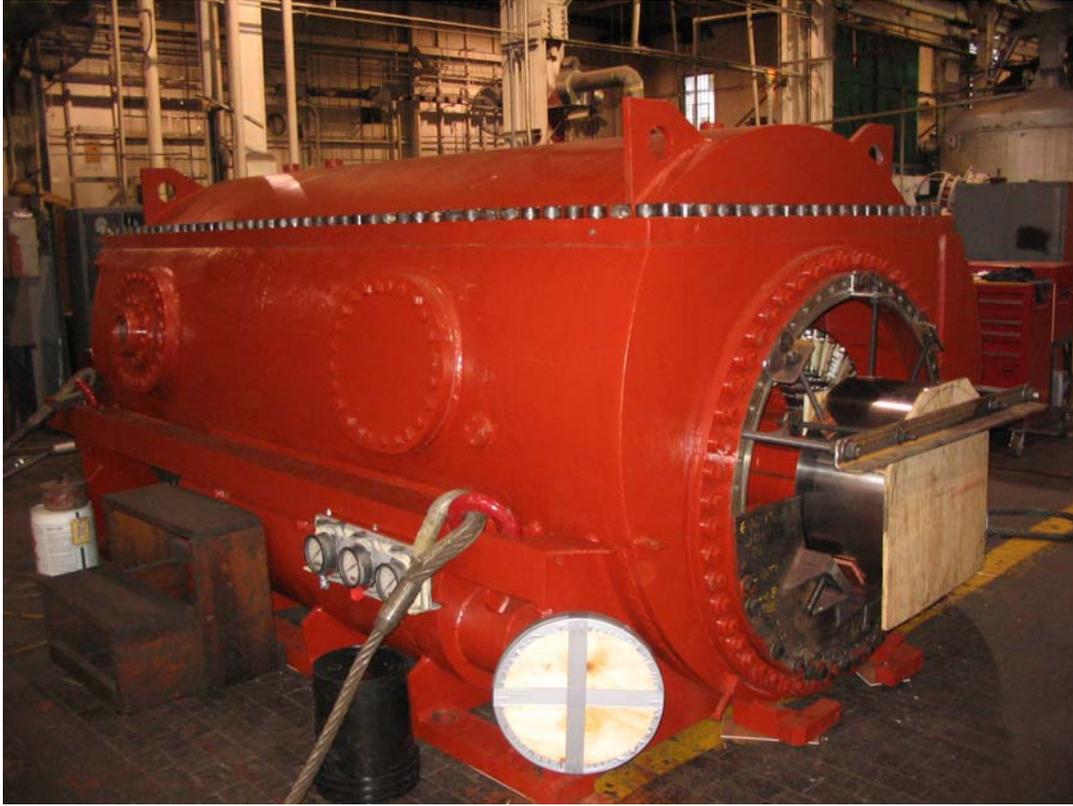
Fig. 11 Exciter after rewind and refurbishment prior to shipping.

Once the rotor was removed from the balance pit, additional insulation resistance tests, armature coil phase to phase resistance tests, and a final Hipotential test was done. The unit was then prepared for shipment.
