# **Condition Assessment Evaluation & Planned Design Improvements for the Cowes Generator William G. Moore, P.E. National Electric Coil U.S.A.**

## **ABSTRACT**

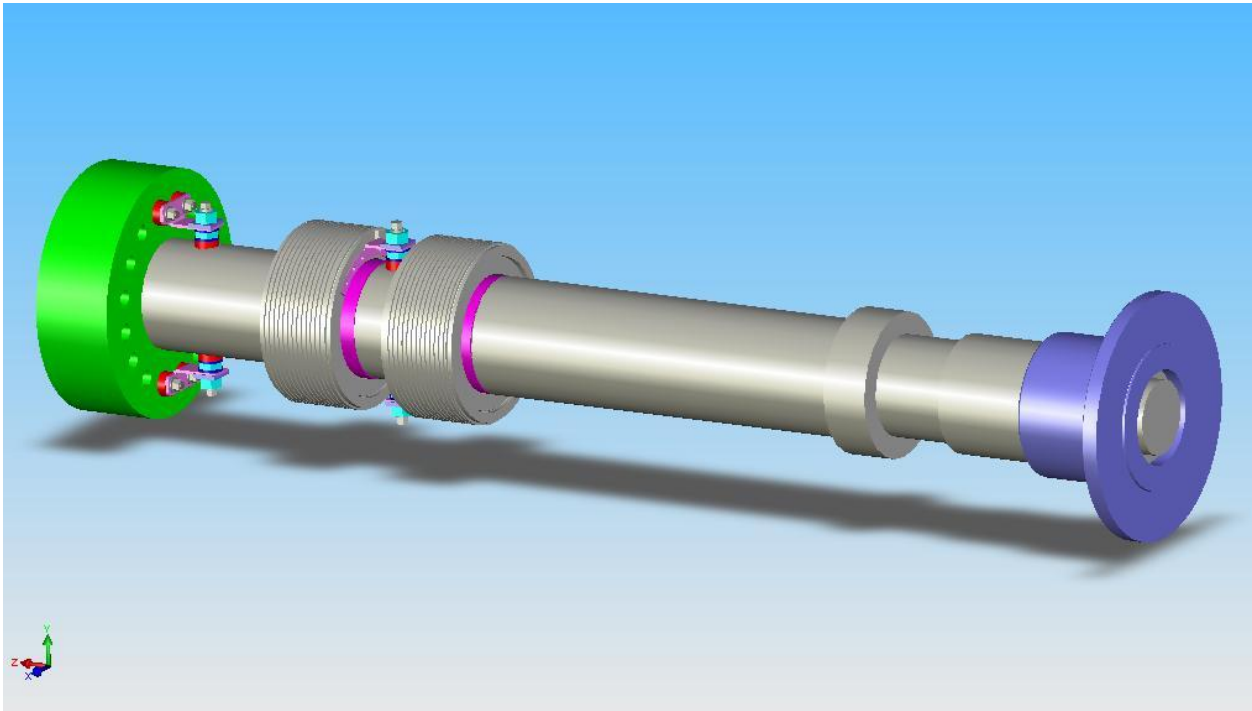
the new exciter connecting shaft and slip rings. In the drawing, the new slip rings and radial conductor leads are clearly visible to the left of the figure.

**Figure 10: Solid model drawing of the new exciter connecting shaft and slip rings.**

- *Replacement with a new Static Excitation System:* This option would incorporate a Digital Exciter System, consisting of a digital excitation controller, fan-cooled rectifier bridge assembly, and power potential transformer (PPT) rated to match customer requirements. The system would be mounted and wired and tested in a NEMA 1 cubicle, complete with accessories. The system would utilize a new exciter shaft with slip rings installed for current feed into the generator rotor. An enclosure would surround the shaft and slip ring assembly, similar to the original exciter enclosure. The existing AVR system would be replaced by the Digital Exciter System. The generator would have black start capability with this system. Below, Figure 10 shows a solid model drawing of

The static excitation option offered a significantly lower price, as well as the promise of less maintenance. It was chosen as the best alternative for the replacement of the exciter.
